Pool Inspection Report

Foxfire Village Pool
14 Foxfire Blvd.
Foxfire, NC 27281

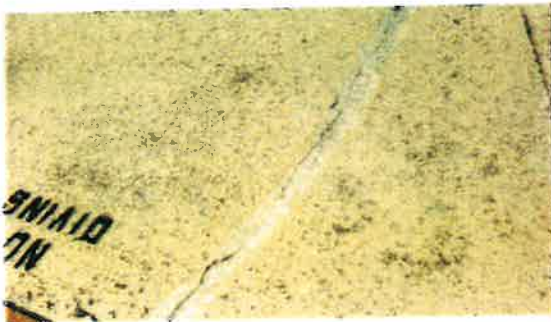
The pool deck showed numerous areas where the deck topping was worn and the underlying concrete deck was visible. Although the majority appears serviceable at this time, there are cosmetic concerns and some cracks and offsets should be addressed. Cracks left unrepaired can contribute to further deck issues down the road.

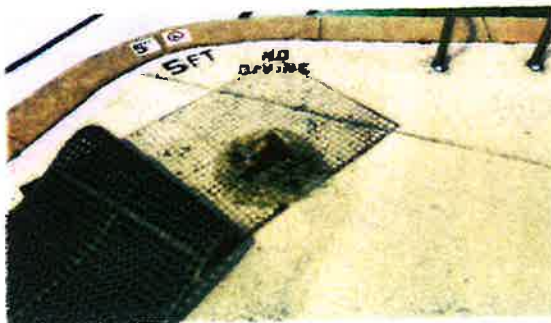
Area where a lifeguard chair was removed is in need of repair. This area would not meet current code requirements and should be corrected.

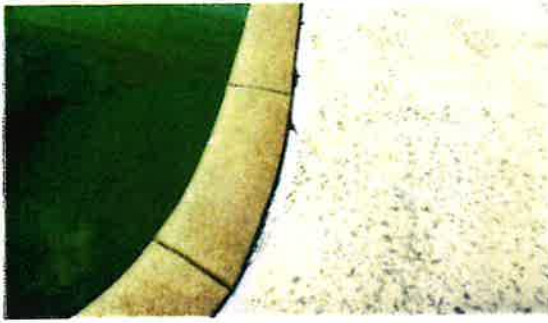
Several areas of the deck have settled and are not flush with the pool coping. The joint between the deck and pool coping shows cracking, spalling, and chipping. Appears serviceable but should be investigated and repaired if needed. ■

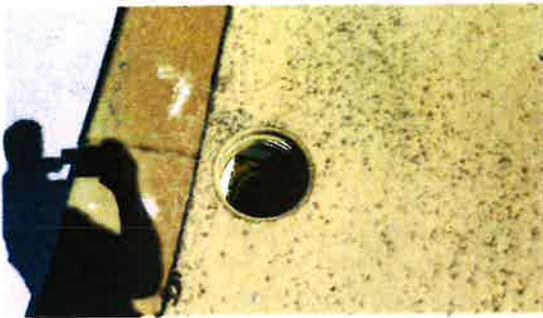
It appears that the original pool coping was removed at some point and replaced with a poured in place coping. The current coping and textured topping is in poor condition showing cracks, spalling concrete, and delaminated topping. There is no expansion joint between the deck and coping. ■

3. It appears that the original pool coping has been removed at some point and replaced with a cast in place concrete coping. The existing coping and the spray texture topping is in poor shape and many areas need repairs. The textured topping is delaminating and spalling concrete under is evident. Many cracks and chipped areas throughout. There was no caulk joint observed between the coping and the pool deck. These items above could be patched but would not be a long term solution.

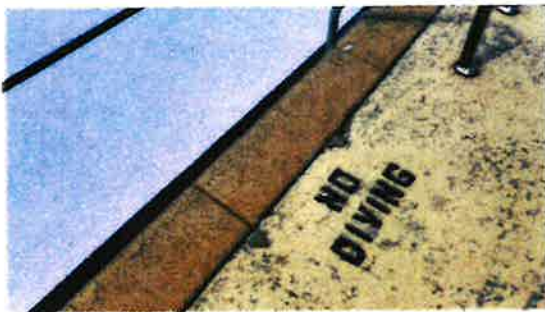
Chipping and cracking at deck to coping transitions should be repaired. ■

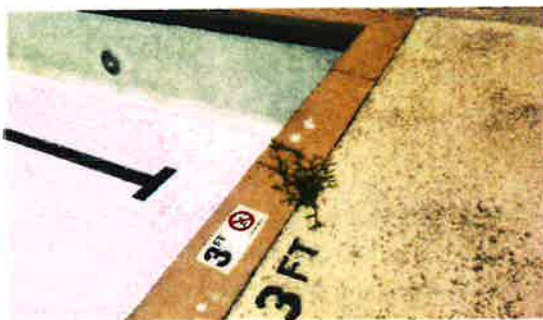
No Diving and depth markers are inconsistent, faded and not easily visible. Joint between deck and coping should be cleaned and caulked.

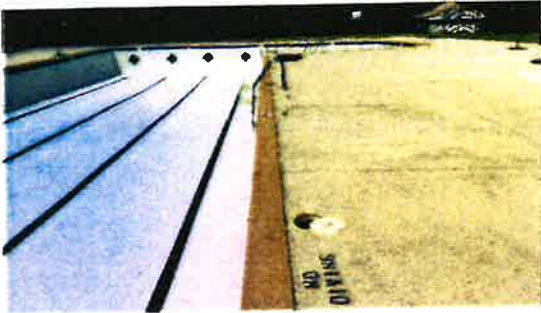
The pool structure appears to be sound and there was no visible cracking or other indication of sub-surface shell/concrete issues.

4. The pool structure (concrete shell) did not show any visible areas of concern. No cracking was observed and no major plaster to shell delamination. There were no cores made or samples tested.

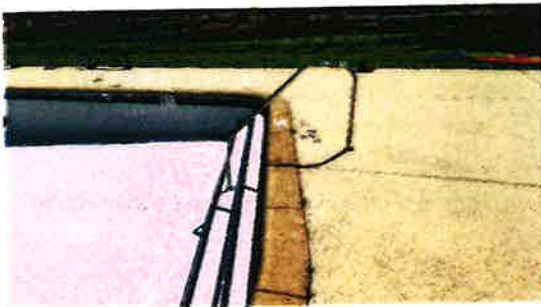
The pool plaster appeared to be in condition expected given the age of the plaster. Staining, rough spots and minor areas of delamination were observed.

5. The plaster finish is consistent with age. Some rough areas and a few minor spots with delamination. It appears the pool has been re-plastered at some point at least once in the past. The new plaster was applied on top of the existing plaster and is evident in the concave areas around the pool returns. Standard re-plaster practice involving multiple layers of plaster would be to chip and remove the existing plaster to get back to the concrete subsurface and apply new plaster.

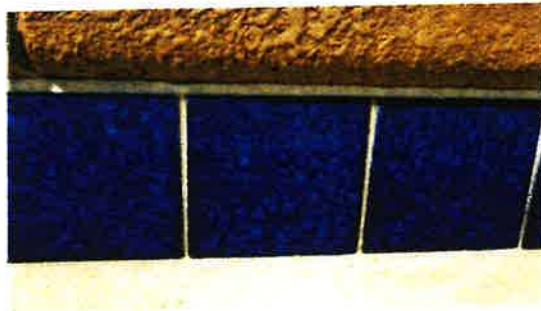
Waterline tile was sound, and no evidence of delamination were observed. The marker and racing lane tile in the pool all appeared to be in fair condition. Grout joints at marker and step tile were missing grout in many places.

6. Pool marker and waterline tiles were in good condition with some areas in need of re-grouting. Tile appears to be sound and bonded to the pool wall and floor. The waterline tile has been replaced at some point and is not original to the pool.

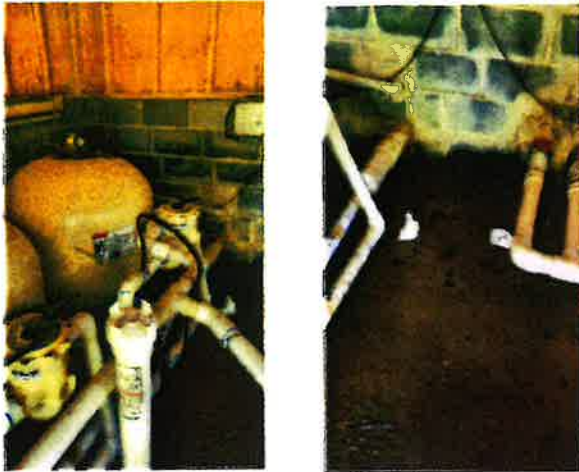
The pool equipment room was not dry, a properly functioning floor drain system was not observed. The overall condition did not appear to meet the code requirements. The filter plumbing had been replaced at some point. The new plumbing is of insufficient sizing does not meet code. Appears serviceable but the concerns above should be addressed and corrected. The pool pump and recirculation system were not operated nor tested. ■

8. The pool lights were not tested.
9. The pump and filter system were not operating as the pool was mainly empty. Standing water and excessive damp conditions. The ventilation system was not operating or inspected. The pump showed above average wear and corrosion due to the wet environment. The plumbing from pump to filter system from filter system to return line has been replaced at some point. The current plumbing is undersized and should be replaced. **No equipment, mechanical, or plumbing (eq room or underground) testing was performed. These items cannot be guaranteed or warranted.**
