# Pressure Testing Report

This document is dated 04/29/2026 and pertains to the commercial pool located on Foxfire Blvd. in the Village of Foxfire.

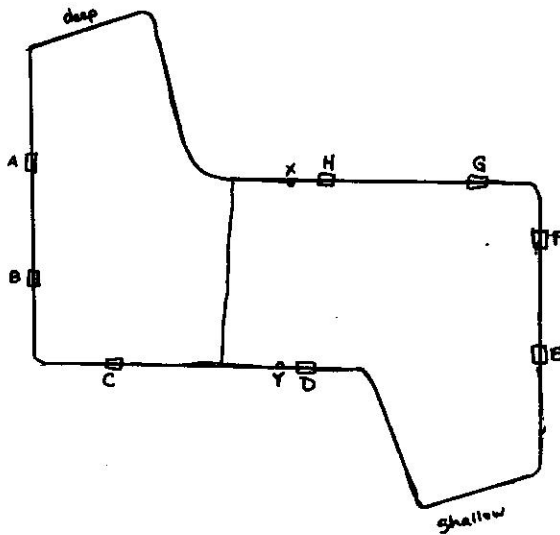
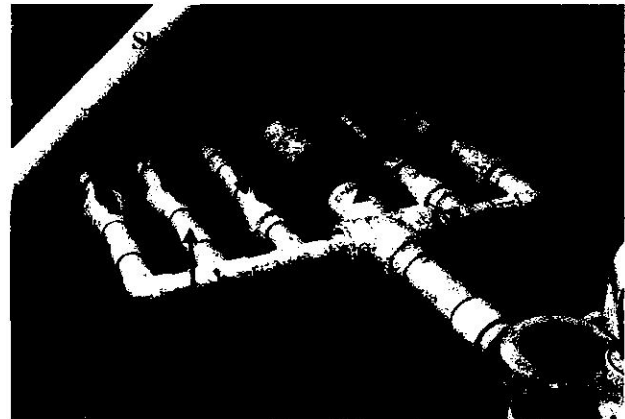
- 2) Pass. X & Y are the 2 cleaner lines. They have their own line in the pool equipment area. These held pressure and no leaks were detected.
- 3) Pass. The main drains are located in the deep end of the pool. Both main drains are tied together on one line in the pool equipment area. These held pressure and no leaks were detected.
- 4) Fail. There are 19 floor returns in the bottom of the pool. Initial pressure test failed and leak was found in pool equipment room. The coupling that was leaking was repaired and the line was tested again. Pressure still dropped but at a slower rate. No bubbles could be seen emerging from around any fitting or from the crack in the pool. A third test with pressurized water was conducted but no water could be seen coming out of any return or the crack in the pool shell.
